trivum troubleshooting

Troubleshooting

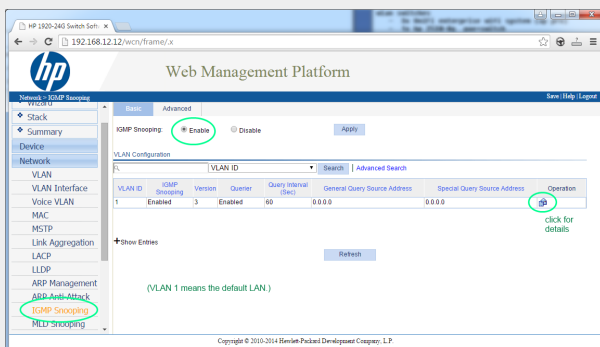
Example configuration with HP 1920G switch:

Figure 1. Screenshot Enabling IGMP Snooping. (use right mouse button, then Open Image)

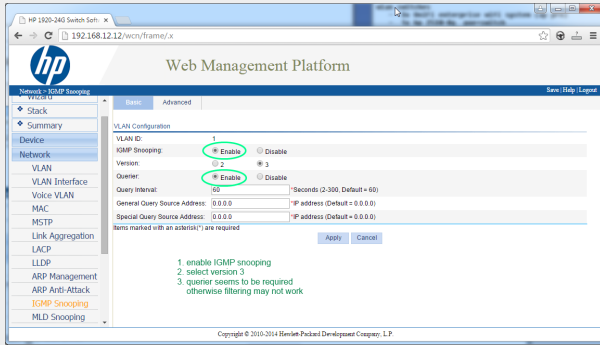
First enable IGMP globally. But then you must also click below Operation and set:

Figure 2. Screenshot Enabling IGMP Snooping and Querier

Enable: IGMP, version 3, with Querier.

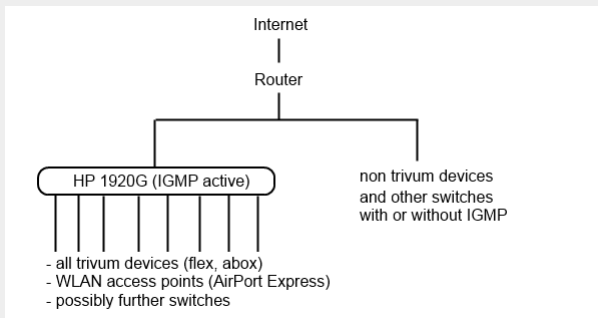
If multiple switches are used then care must be taken that either all support IGMP, or that the one supporting IGMP is placed at the top, containing all trivium devices.

So the network should look like, for example:

Figure 3. Topology

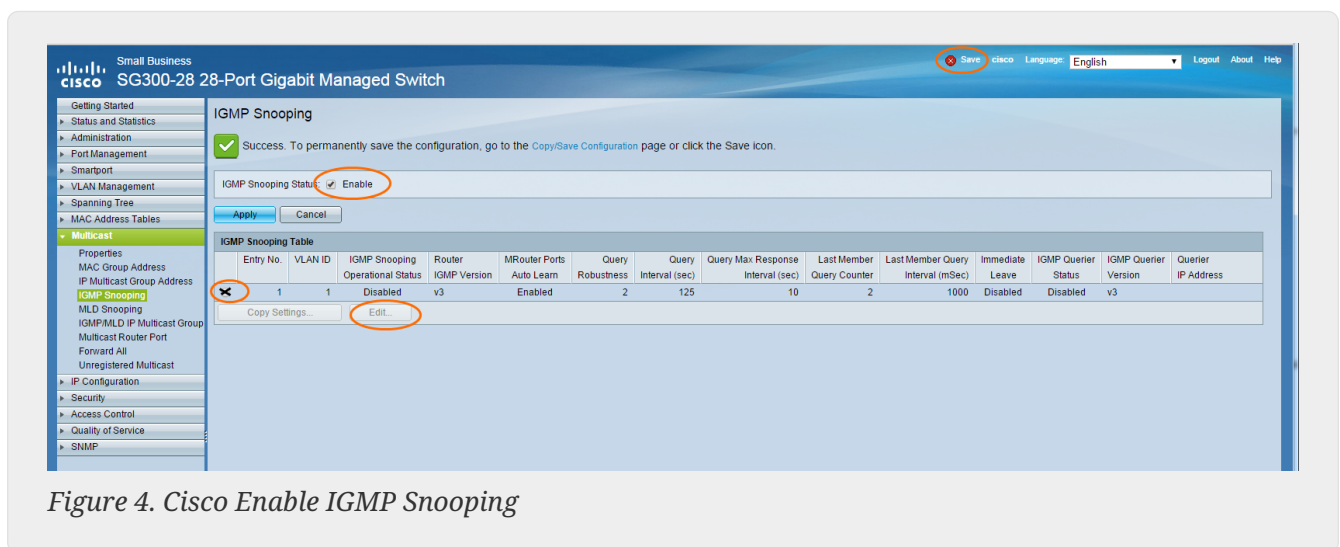
After setting these values, wait 2-3 Minutes before filtering becomes active. Select the blinking "save" button at the top then select: source/running config, destination/startup.

Figure 4. Cisco Enable IGMP Snooping

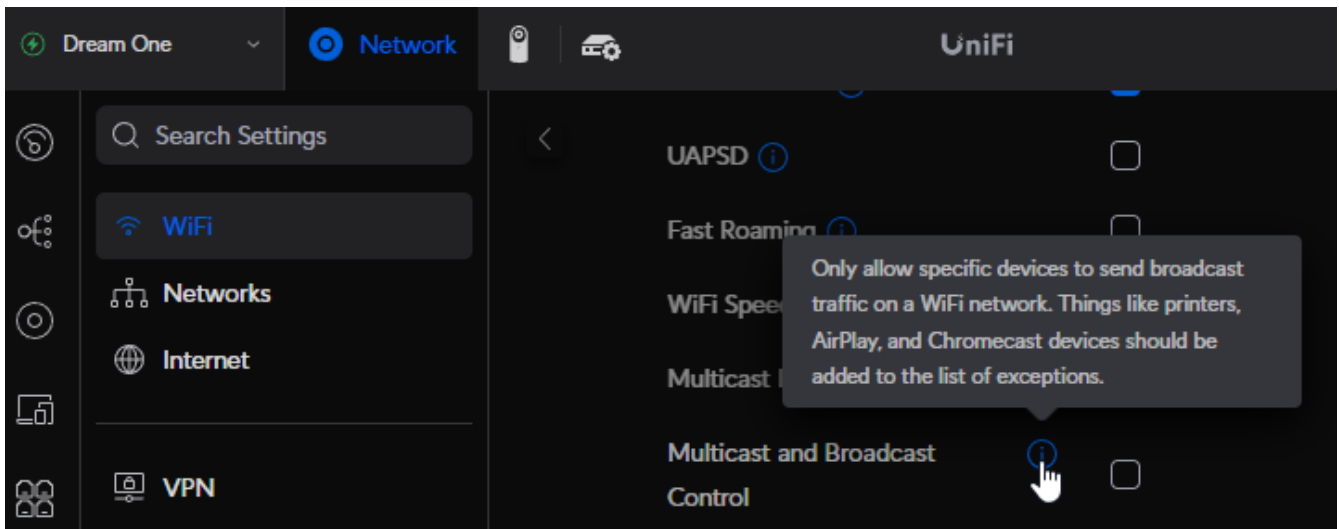
- Settings / WiFi / (select network) / Advanced (Manual) / Multicast Extension
- Settings / WiFi / (select network) / Advanced (Manual) / Multicast and Broadcast Control

If "Multicast Extension" is set, disable it. The intention is to convert Multicast traffic to unicast, which is not supported by trivum devices.

If "Multicast and Broadcast Control" is set, disable it for a test. If it is required in your network to have it set, extend the setting, by adding trivum device MAC Addresses to the list of exceptions.

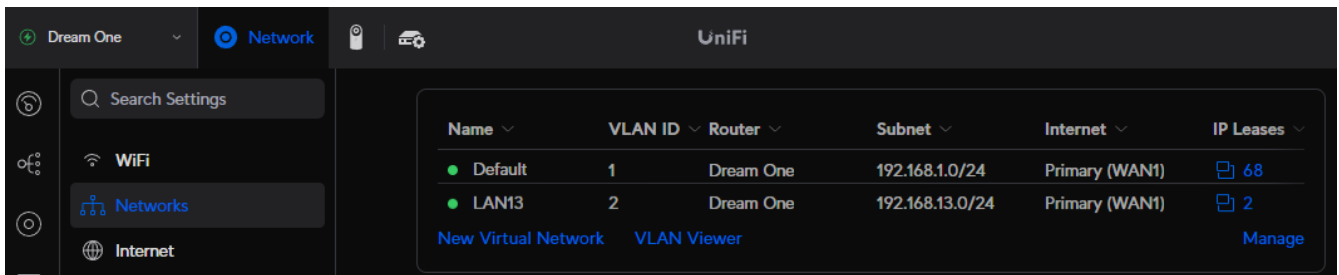
In your Unifi switch, go to "Settings / Networks" to get a list of your VLAN's, for example:

The screenshot shows the UniFi Network settings page. On the left, there is a sidebar with navigation options: Search Settings, WiFi, Networks (selected), and Internet. The main content area displays a table of VLANs. The table has columns for Name, VLAN ID, Router, Subnet, Internet, and IP Leases. There are two entries: 'Default' with VLAN ID 1, Subnet 192.168.1.0/24, and 68 IP leases; and 'LAN13' with VLAN ID 2, Subnet 192.168.13.0/24, and 2 IP leases. Below the table, there are links for 'New Virtual Network' and 'VLAN Viewer'. A 'Manage' link is also present at the bottom right of the table.

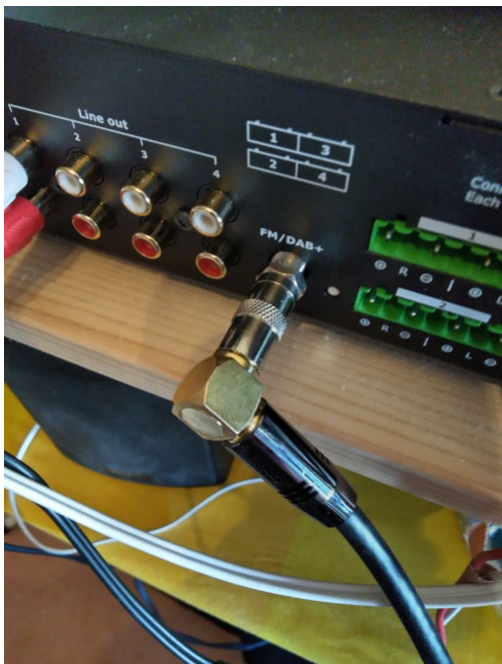
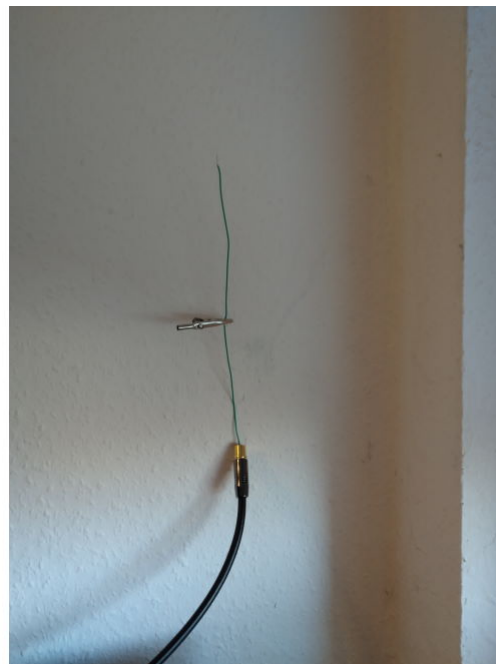
- get a 2m or longer shielded antenna cable, and suitable adapters. connect that to the SC344m antenna connector.
- at the other side of the cable, several meters away from the SC344m, connect your simple wire, or a throw antenna. This should be sufficient at living room level or higher.

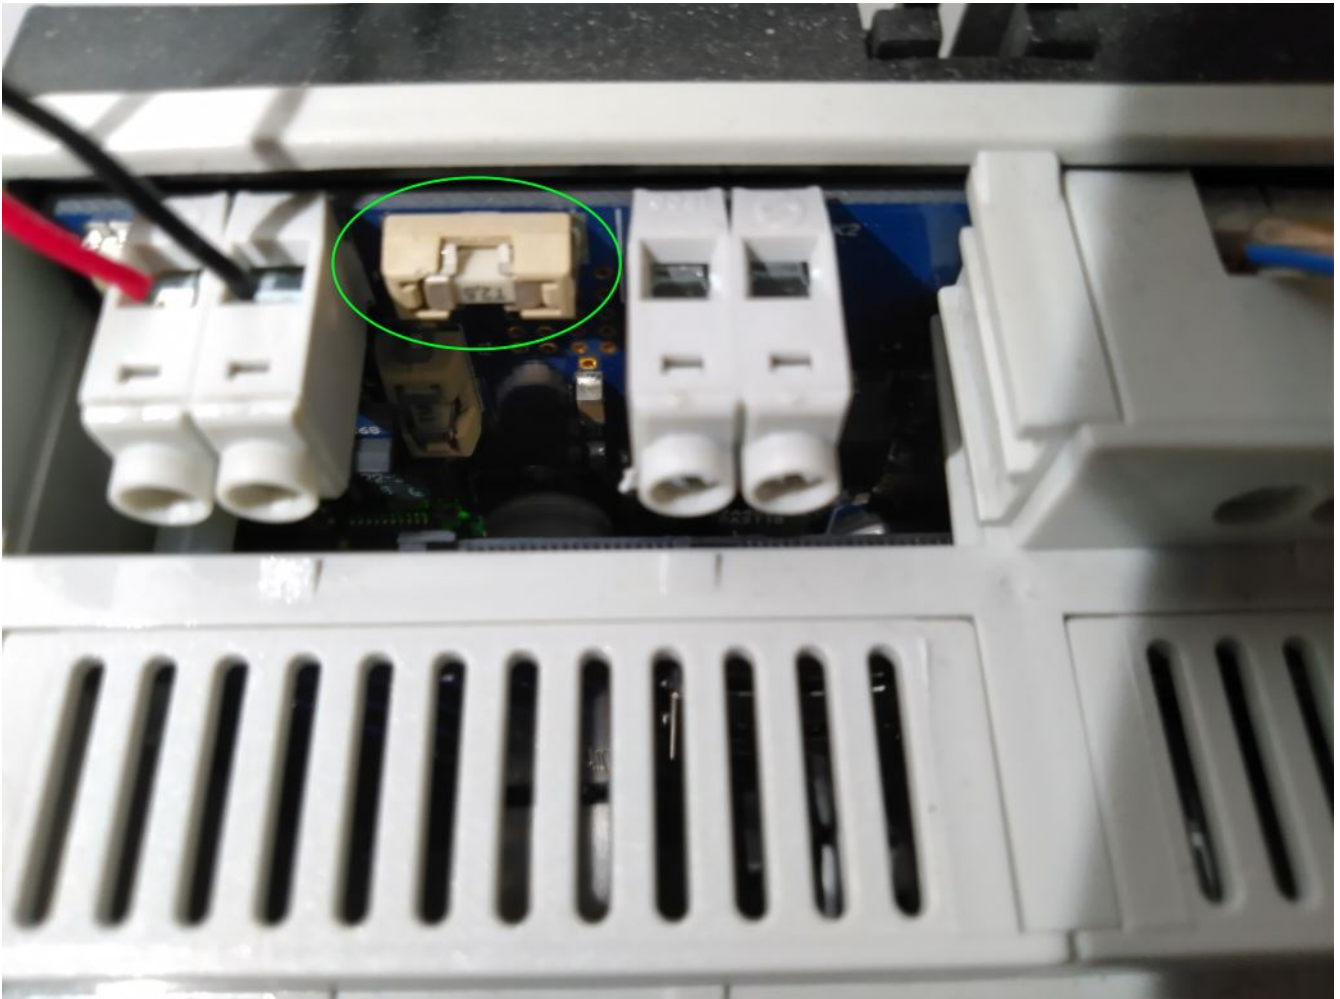
open one cover part of the casing. the fuse directly at the power connector is the relevant one.

It's a Siba 158000.2,5 oder Littlefuse 045202.5MRL.
