trivum troubleshooting

Troubleshooting

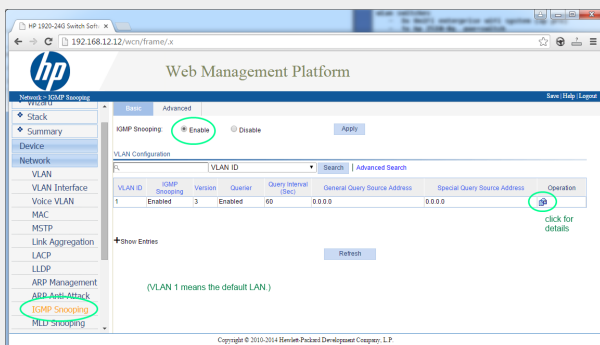
Example configuration with HP 1920G switch:

Figure 1. Screenshot Enabling IGMP Snooping. (use right mouse button, then Open Image)

First enable IGMP globally. But then you must also click below Operation and set:

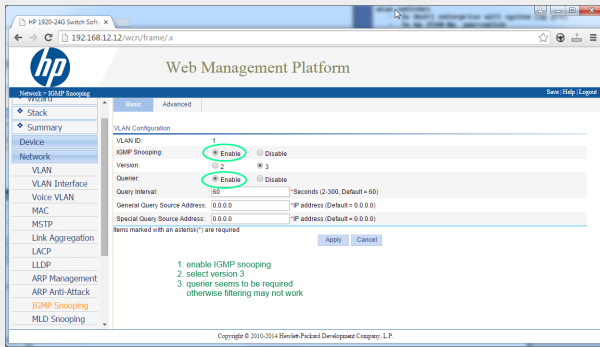
Figure 2. Screenshot Enabling IGMP Snooping and Querier

Enable: IGMP, version 3, with Querier.

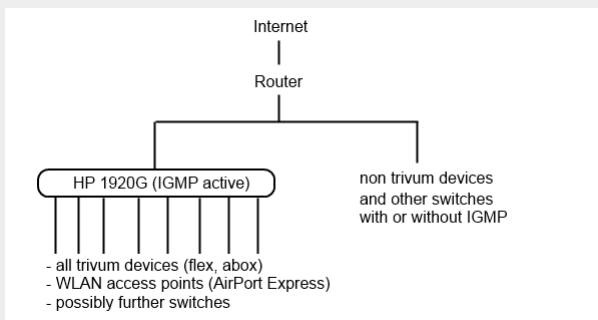
If multiple switches are used then care must be taken that either all support IGMP, or that the one supporting IGMP is placed at the top, containing all trivium devices.

So the network should look like, for example:

Figure 3. Topology

To avoid flooding of non trivium devices by unwanted audio messages.

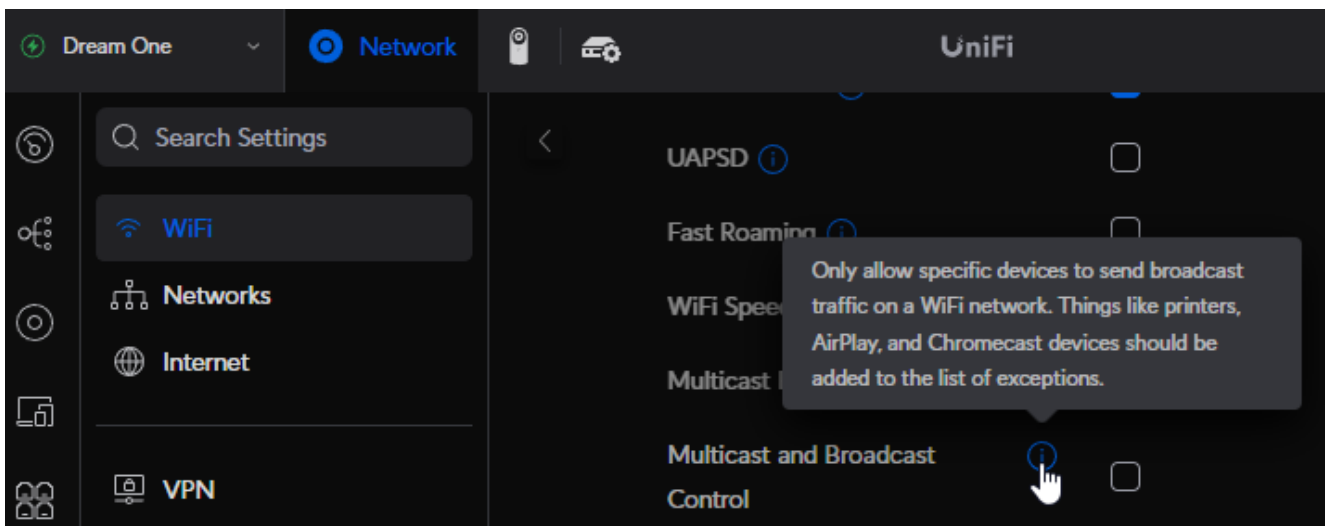
- Settings / WiFi / (select network) / Advanced (Manual) / Multicast Extension
- Settings / WiFi / (select network) / Advanced (Manual) / Multicast and Broadcast Control

If "Multicast Extension" is set, disable it. The intention is to convert Multicast traffic to unicast, which is not supported by trivum devices.

If "Multicast and Broadcast Control" is set, disable it for a test. If it is required in your network to have it set, extend the setting, by adding trivum device MAC Addresses to the list of exceptions.

In the management page of a Unify Dream One / UDM Pro Switch, the following settings are most relevant for the (non) visibility of AirPlay inputs, Spotify Connect inputs, and discovery of trivium devices by the trivium App:

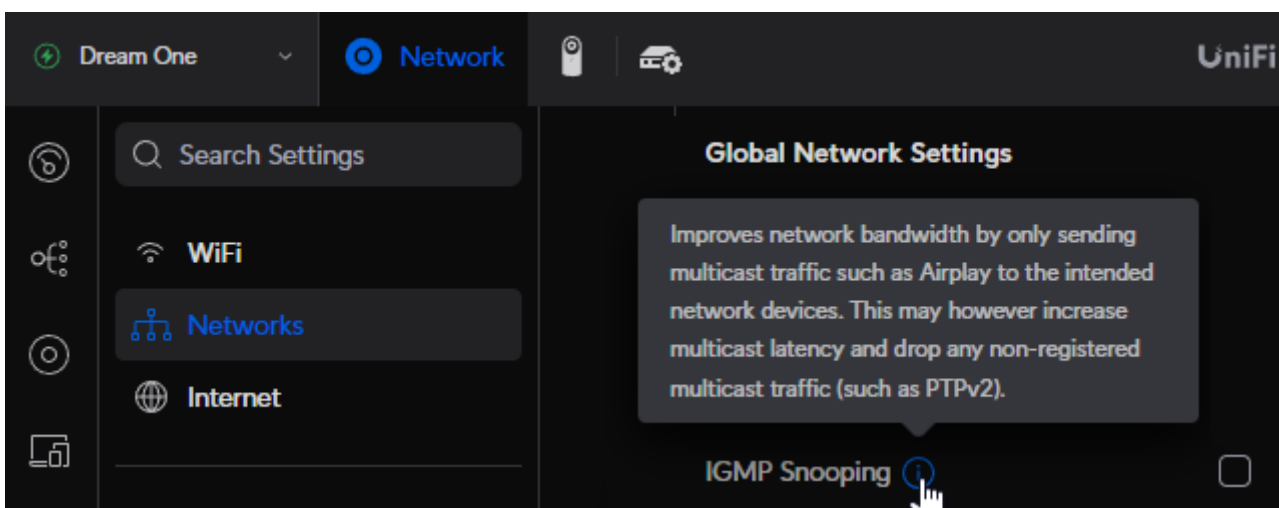
- Settings / Networks / Global Network Settings / IGMP Snooping

If this is set, disable it for a test. If your network experiences overloads, e.g. during group play over many devices, enable it.

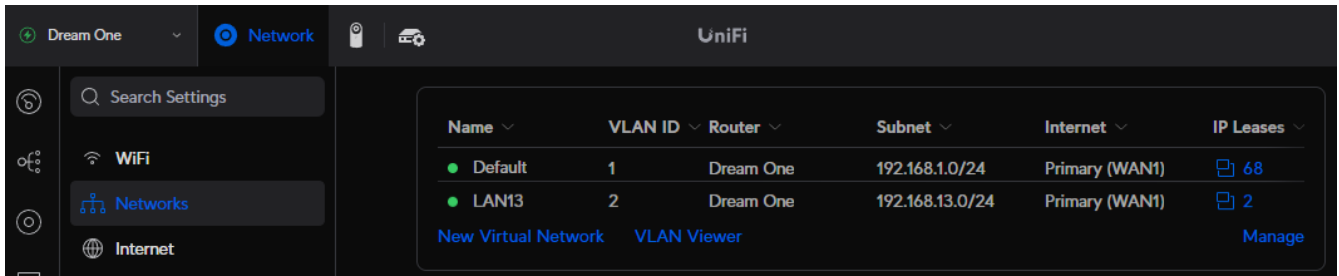
In your Unifi switch, go to "Settings / Networks" to get a list of your VLAN's, for example:

The screenshot shows the UniFi Network settings page. On the left, there is a sidebar with navigation options: Search Settings, WiFi, Networks (selected), and Internet. The main content area displays a table of VLANs:

Name	VLAN ID	Router	Subnet	Internet	IP Leases
Default	1	Dream One	192.168.1.0/24	Primary (WAN1)	68
LAN13	2	Dream One	192.168.13.0/24	Primary (WAN1)	2
